UNC Nutrient Management Study - In Situ Observational Study of Falls Lake Year 1 Report

Rick Luettich, Tony Whipple

UNC-CH Institute of Marine Sciences

7/30/2020

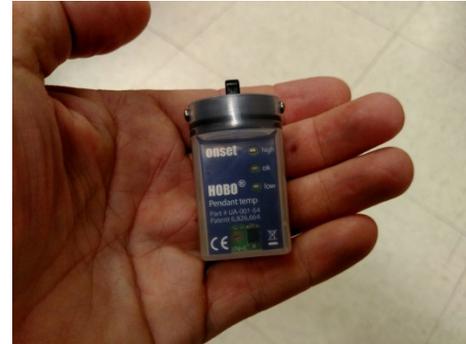
Figure 4. Moorings and typical Hobo sensor

Near the three downriver ADCPs we deployed moorings to measure temperature, irradiance, conductivity and water depth to aid in understanding thermal stratification and light extinction. (The I85 site was not included due to shallow water, difficulty of access, and the co-location of a vertical profiler station operated by the NCSU CAEE.) Each mooring consists of two parts, one suspended below a surface float and the other attached to the bottom using a taught line and submerged float, (FIGURE 4). This arrangement allowed the full water column to be sampled while allowing for a possible change in lake level of as much as 19 ft. Each mooring contained approximately 20 HOBO temperature sensors (FIGURE 4) spanning the water column at 0.5 m intervals. A conductivity sensor was included at 2.2 m below the surface and the upper few HOBOS also included light sensors. Pressure sensors were included on top of the surface float (to measure atmospheric pressure) and at the top and bottom of the surface and bottom mooring components to determine total water depth and position of the sensors over depth as total water depth varied with lake level. Data were collected every 6 – 12 minutes. Due to fouling of the light and conductivity sensors, the part of the mooring attached to the surface float was intended to be recovered and cleaned monthly. At that time, vertical profiles of photosynthetically active radiation (PAR), (Li-Cor model LI-193 spherical sensor) and water quality indicators (Endeco-YSI multi-parameter probes models 6600 or EX02) were collected from the attending boat to assist with calibration of the moored sensors and further enhance the data set. Temperature data from all sensors on each mooring have been aggregated to provide information on temperature over depth and time and mapped onto a grid every 6 minutes for subsequent analysis. The pressure measurements were used to track the relative depths of the surface and bottom moorings.

As noted previously, only the temperature data from the top half of the split mooring (cf. [FIGURE 4](#)) have been processed to date. Thus, the temperature data presented in [FIGURE 9](#) represent only the upper portion of the water column. These temperatures ranged from approximately 5-25 deg. C and stratification can be seen to form at all sites during periods of warming. During periods of cooling such as in November, the upriver section cools more quickly than the deeper downriver section. The increased density of the cooler water can lead to along-lake density driven currents.
